28 February 2023

Rapid boiler feed pump repair and root cause analysis ensure power generation reliability

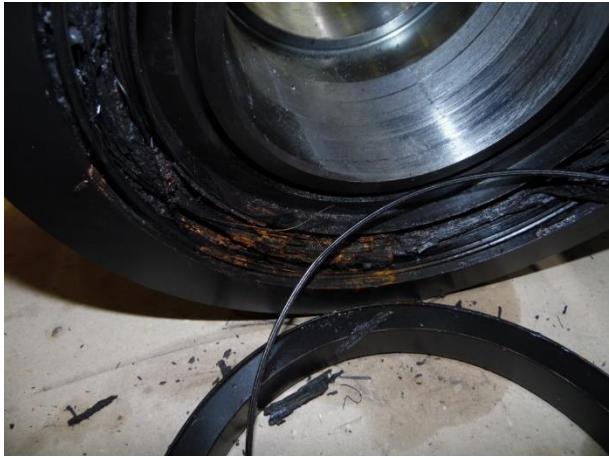
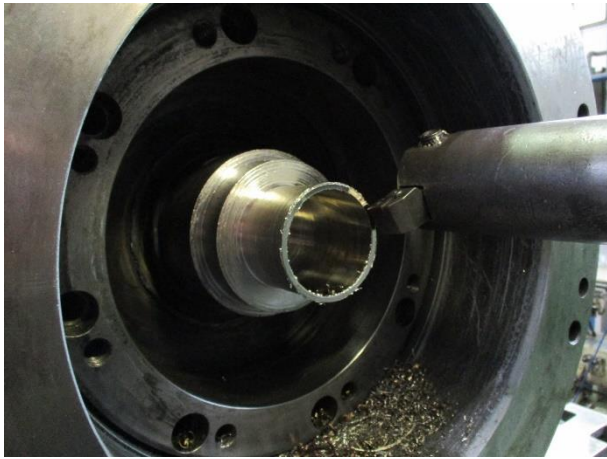
The initial investigation found that the balance piston and sleeve were welded together and this would require the shaft to be cut off and drilled out to separate the parts. The piston was replaced while a boring machine was used to bore out the sleeve to its original dimensions and complete the repair.

With the power plant running two of these pumps, the operator was very keen to identify the root cause of the initial problem to enable any additional preventative measures to be taken. During the inspection, there was evidence that a steam bubble was present in the area around the balance piston, indicating a lack of cooling and lubrication, which led to a massive rise in temperature.

Some information that was missing during the initial investigation was that the plant suffered an unexpected shutdown two or three days before the pump failure took place. Once the reason for the shut-down was resolved, the pump was restarted, however, during this process a procedural issue was determined as the root cause of the subsequent pump failure, confirming the operational reliability of the pump.

Image 1 & 2: The initial investigation found that the balance piston and sleeve were welded together and this would require the shaft to be cut off and drilled out to separate the parts

The repaired balance piston was then fitted together with the spare rotor, which had passed its inspection. All the additional spare parts required for the repair were also on-hand having been ordered for urgent delivery.

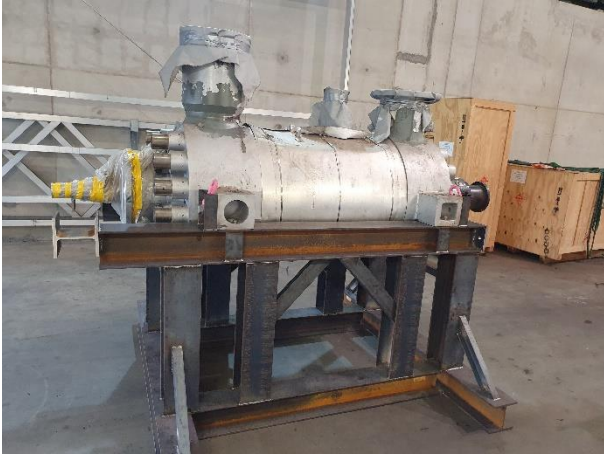
Image 3: The pump was removed and transported to Sulzer's service center in Jänschwalde to enable the necessary repairs to be completed
