Legacy doesn't mean end of life

Breathing new life into pumps of any age from any brand with OEM knowledge

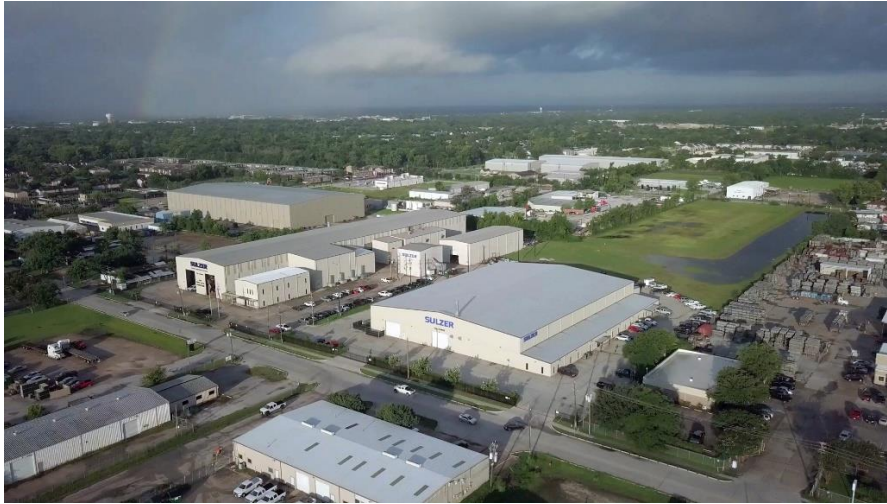
Image 1: The Sulzer pump service center in Pasadena redesigned and created the remaining components needed for the repair

Working in parallel with the parts manufacturing department, the pump service center in Pasadena redesigned and created the remaining components needed for the repair. These were less complex and consisted mainly of sleeves, wear parts, shafts, and rings. The parts were redesigned using 3D CAD software and manufactured according to specifications derived from Sulzer's expertise as a pump OEM.

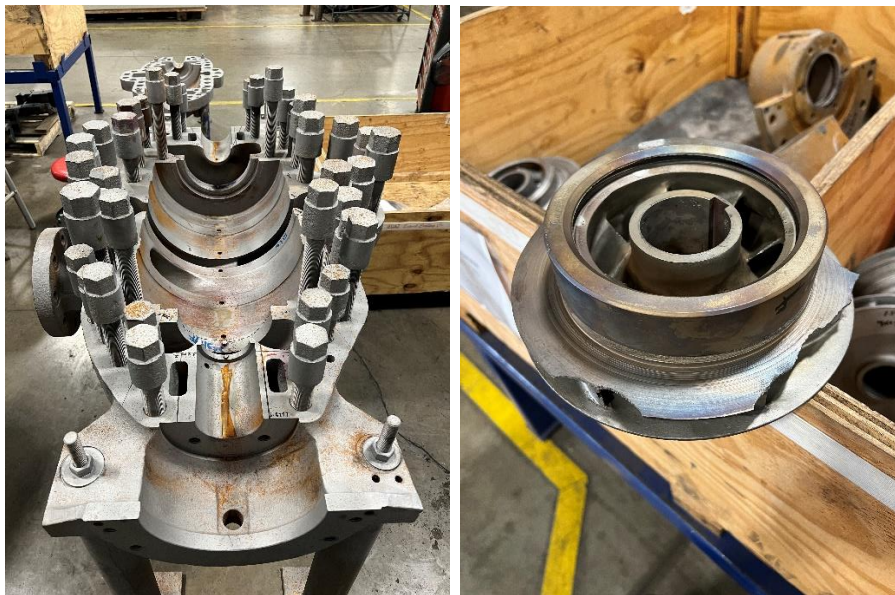
The pump in question was a between-bearing, six-stage type working with propylene carbonate. The failure happened when the rotating assembly spun contrary to its designed direction for a considerable period of time, leaving behind damage to all the stationary and rotating elements contained in the pump.

Initial investigations found many diffuser guiding vanes bent or broken, as well as diffuser walls that had cracks and wear damage due to the contact with the impellers to the point where they could not be repaired. There was substantial damage to all internal parts as well as rubbing marks present on all elements. Most of the wear rings had become stuck between the stationary and rotating elements or were worn out of shape altogether. Some stationary rings were absent from their locations and several impeller walls were cracked or broken and couldn't be used again.

Image 2 + 3: The pump in question was a between-bearing, six-stage type working with propylene carbonate, with damage to all the stationary and rotating elements contained within

The first step was for the design engineering team to reverse engineer the complex items, such as impellers, and diffuser passageways, using 3D laser scanning. This can render a component's geometry with an accuracy of 0.0005" (0.013 mm), allowing the design engineer to capture an accurate, digital mesh of the part.

The mesh enables complex measurements and sketch geometry details to be obtained. A solid 3D CAD model was then translated into a 2D sketch to perform the quality audit (QA) and control processes on the scanned parts. Once the QA process was complete, the parts manufacturing department was tasked with producing the components by translating the model into a CAD-appropriate file to create molds and patterns for casting. These were machined according to the final specifications and dimensions requested by the repair engineer and returned to the service center.

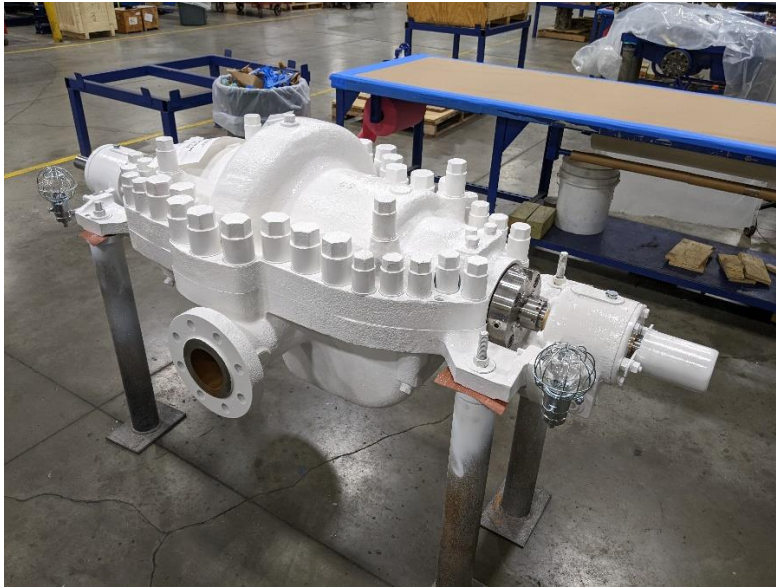
Image 4: Once all parts were received, they underwent a preassembly process to allow the technicians to verify the fit and design of the new component, before the pump was prepared for shipment back to the customer

Once all parts were received, they underwent a preassembly process to allow the technicians to verify the fit and design of the new components. Finally, the pump was assembled and hydraulically pressurized to 1.5 times maximum allowable working pressure (MAWP) to ensure no leak paths were present and overlooked during the repair, before the pump was prepared for shipment back to the customer.
