## Revitalizing a 99-year-old hydropower turbine

### **Sulzer Indonesia carries out critical repairs for historic hydropower plant in West Java**

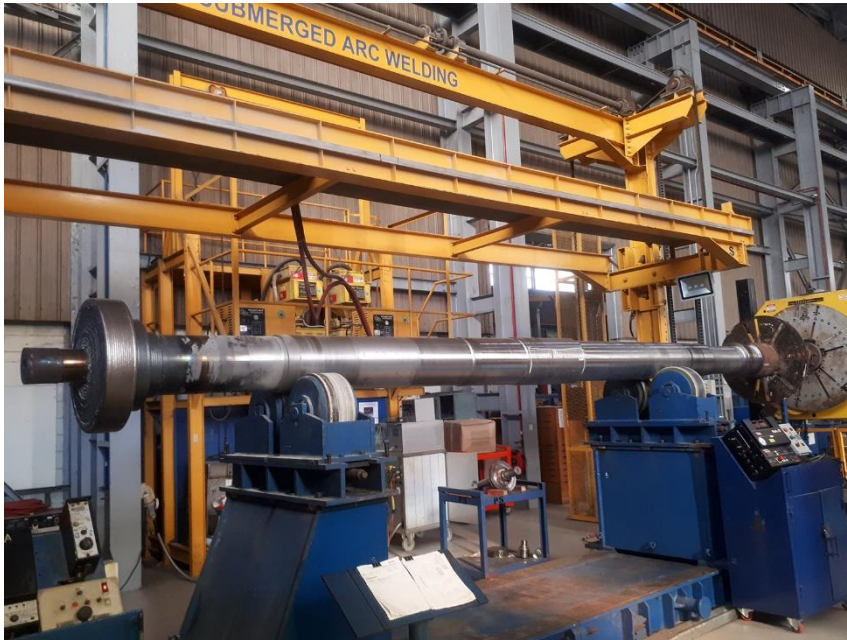
**Image 1:** Submerged arc welding (SAW) was used to apply an upgraded, high-strength low-alloy steel weld material, building up the diameter of the shaft.

The project started with the more complex repair of the broken shaft. In terms of direct replacement, the only option to source a shaft of the correct diameter was to order from overseas. This was unacceptable due to the long lead-time, so instead, Sulzer Indonesia sourced a smaller diameter shaft locally and built it up on the coupling area to the correct size.

This process has been used by Sulzer Indonesia since 2002 as it enables rotors to be weld repaired instead of being scrapped. The technology has been adopted from Sulzer's Houston Service Center, showing the transfer of expertise through the wider global network. In this case, submerged arc welding (SAW) was used to apply an upgraded, high-strength low-alloy steel weld material, building up the diameter of the shaft. Once completed, the shaft was precision machined to the final dimensions and comprehensively tested.

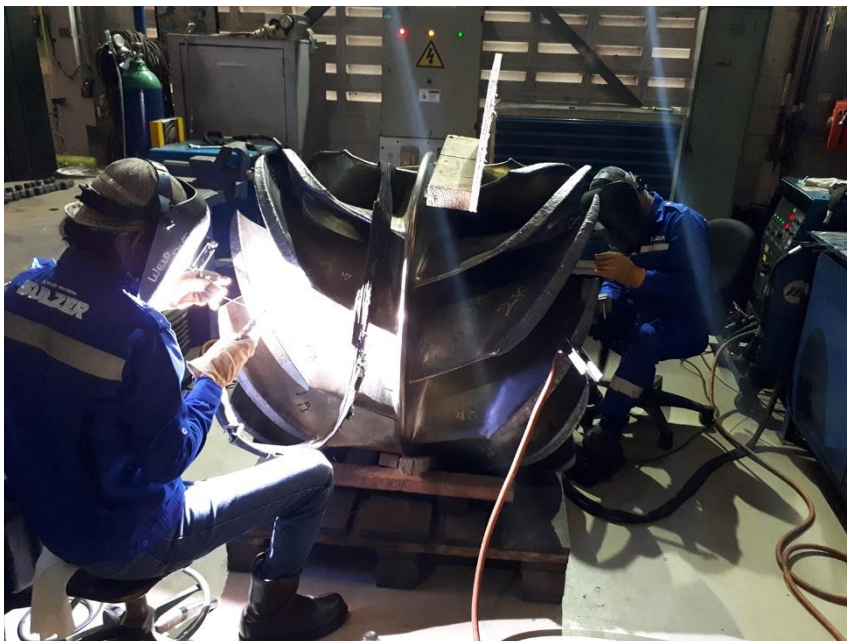
**Image 2:** Specialist welding processes were used to clad the blade tips with corrosion resistant material, ensuring an optimum repair.

The damaged turbine tips also needed to be repaired. Sulzer used laser scans in conjunction with reverse engineering techniques to ascertain the as-new dimensions. Then, specialist welding processes were used to clad the blade tips with corrosion resistant material, ensuring an optimum repair.

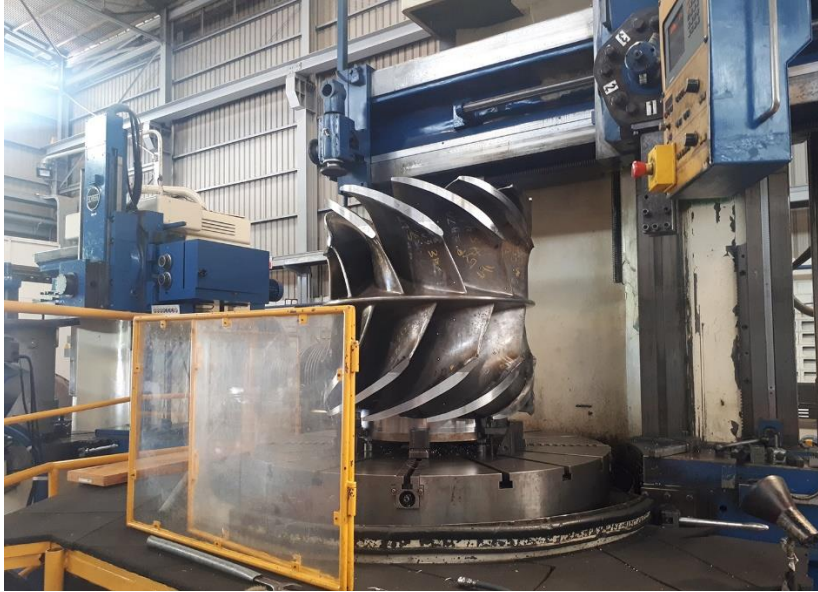
**Image 3:** Machining of the repaired turbine tips.
