28 February 2023

Rapid boiler feed pump repair and root cause analysis ensure power generation reliability

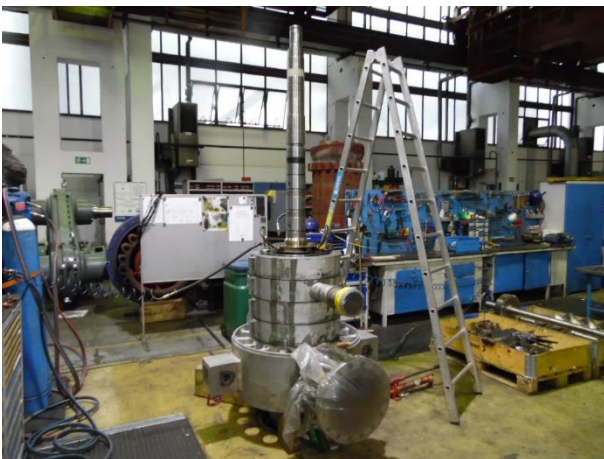
Image 3: The pump was removed and transported to Sulzer's service center in Jänschwalde to enable the necessary repairs to be completed

Sulzer's service center in Jänschwalde to enable the necessary repairs to be completed.
