### Avoid bearing the cost of failure

# Rapid motor rewind brings motor back online ahead of schedule and minimizes lost production

### 18 June 2024

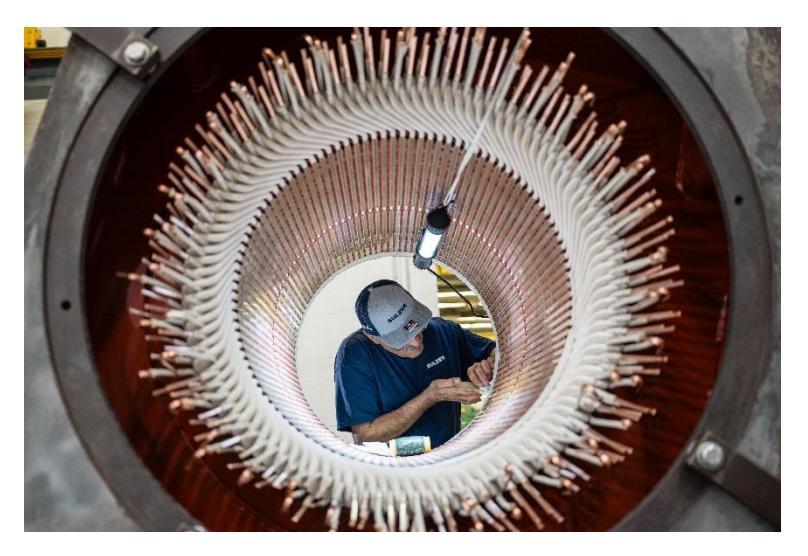
**Image 1:** Sulzer's quick response and outstanding service has ensured that the motors have been returned to service at the earliest opportunity.

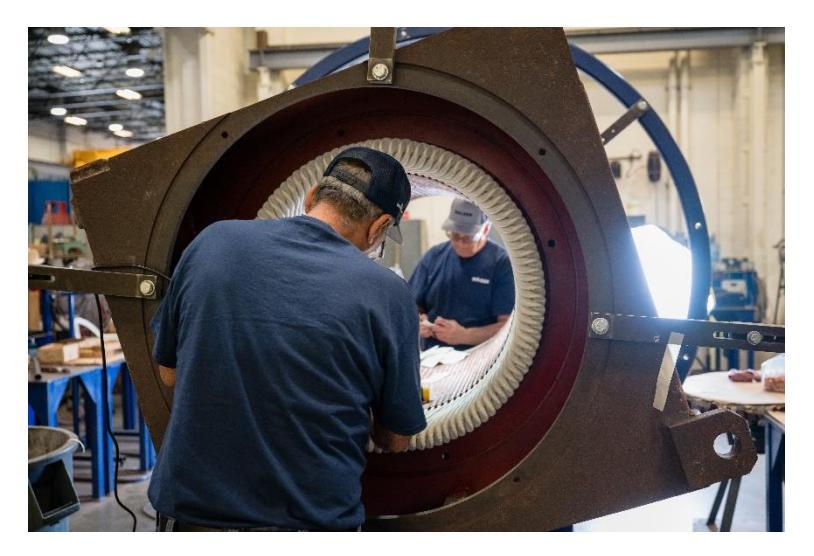
**Image 2:** Sulzer has regularly carried out planned maintenance and overhauls of rotating equipment for the minerals company.
