Quick response maintenance service beats OEM support

29th November 2022

Sulzer called in to overhaul storm pump after extended delays

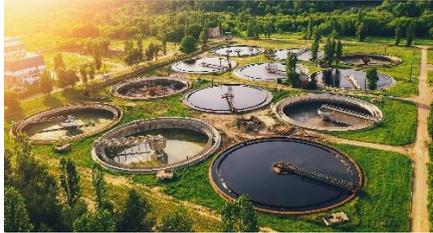
Image 1: The storm pumps had been in operation for around 25 years and were in need of a serious overhaul. [Image source: shutterstock_1752757748]

The storm pumps at a wastewater treatment plant had been in operation for around 25 years and had reached the point where a complete overhaul was required before a potentially serious failure was experienced. Regular vibration monitoring had highlighted the need for a refurbishment, but the situation had been exacerbated by the lack of support from the OEM.

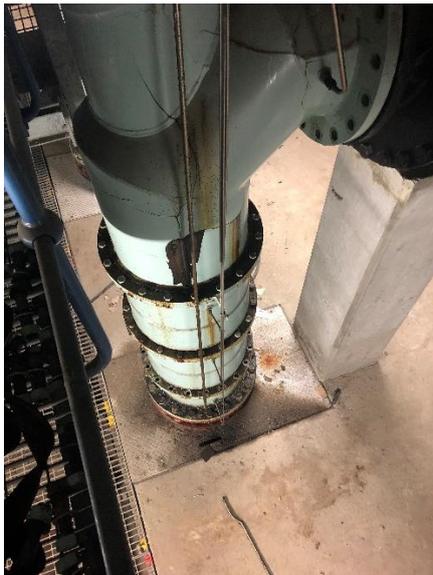
Image 2: The project involved the complete overhaul of the pump and motor assemblies, all of which could be completed at the same location.

The project involved the complete overhaul of the pump and motor assemblies, all of which could be completed at the same location. As a turnkey solution, Sulzer provided field service engineers to arrange the lift and removal of the pump as well as the reinstallation of the full unit including motor, after the refurbishment had been completed.

Once the pump had been disassembled, all the components were inspected and identified for replacement or re-engineering. A considerable amount of corrosion was found on the impeller and the suction sleeves. Sulzer applied a specialist coating on all parts that required additional protection against corrosion to extend the operating life of these components.
