A cracker of an upgrade

Targeted pump and turbine retrofits boost output and reliability at Philippines naphtha cracker

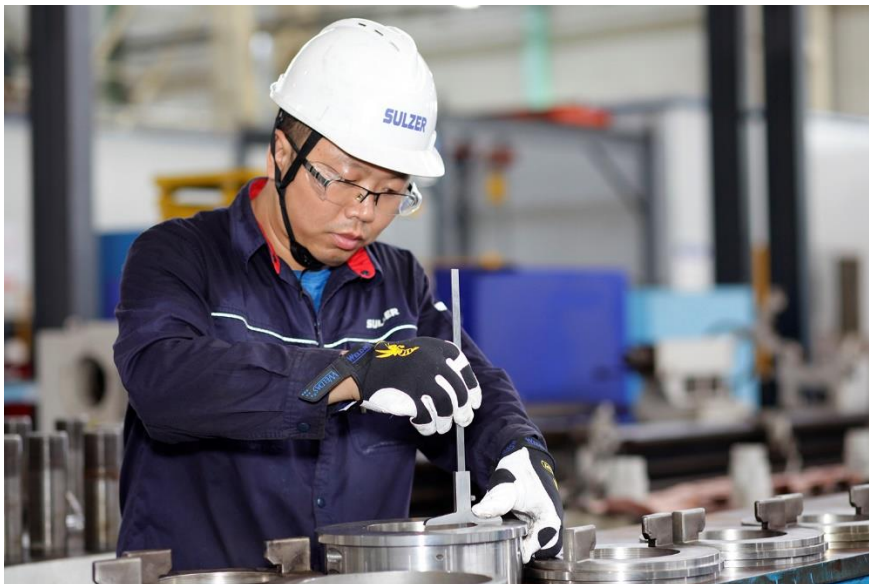
Image 2: The pumps were upgraded and tested at Sulzer's facilities, ensuring that they could be reinstalled with no major changes to pipework or ancillary equipment.

One big benefit of Sulzer's retrofit proposal was minimal disruption at the plant. The pumps were upgraded and tested at Sulzer's facilities, ensuring that they could be reinstalled with no major changes to pipework or ancillary equipment. To gain even

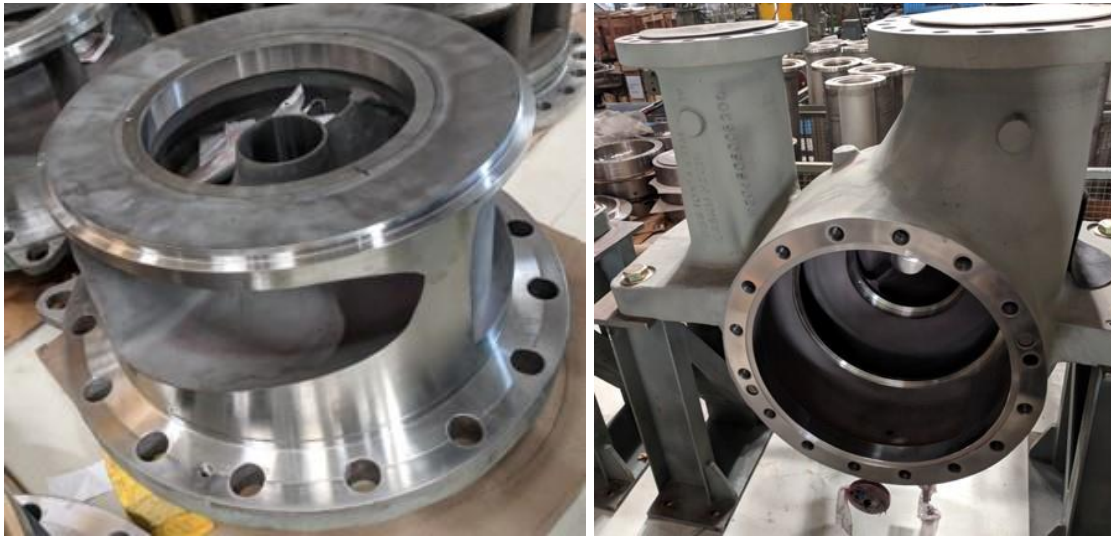
Image 3 + 4: Material upgrades using high-chromium steel.

Those changes included the selective replacement of critical pump components with new parts made from high-chromium C6 steel, together with the addition of an abrasion resistant SUME SA30 coating on the wetted areas, applied using a high velocity oxygen fuel (HVOF) process. Sulzer's specialists also made several detailed changes to the geometry of the pumps, including the addition of large radii on the edges of the wear rings and extended, contoured sleeves to streamline flow in the pump and minimize the turbulence that accelerates wear. Wear ring clearances within the pumps were increased to allow larger coke particles to pass through them. In addition, at the customer's request, new ports were also introduced to allow the wear rings to be flushed to remove accumulated particles during pump changeovers.
