Compressing times

08 November 2023

Sulzer appointed to repair compressor after OEM failed to meet expectations

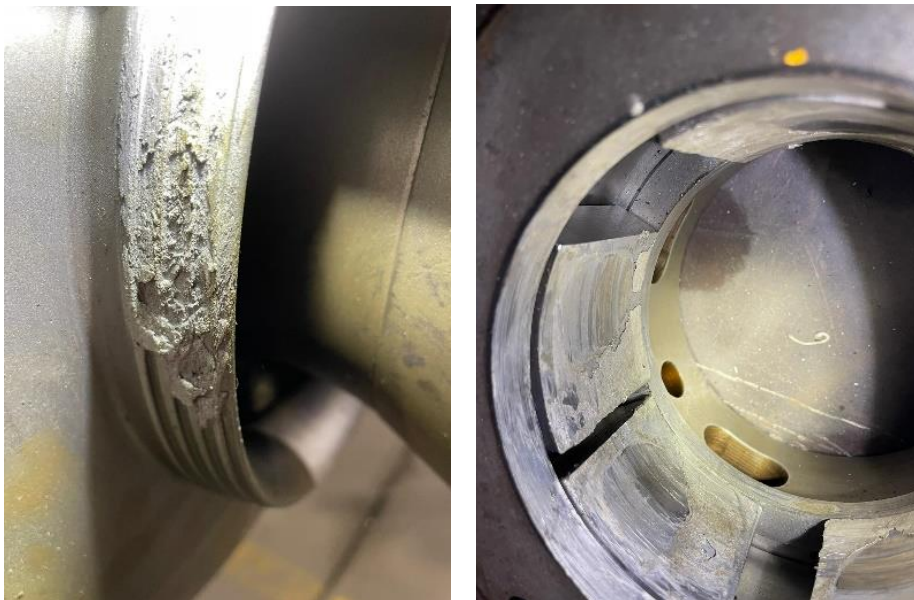
Image 2 + 3: It was suspected that the rotor was incorrectly aligned during installation, which led to the impellers making contact with the casing and causing damage to the seals.

It was suspected that the rotor was incorrectly aligned during installation, which led to the impellers making contact with the casing and causing damage to the seals. Having lost faith in the OEM to complete the project to the required standard, the company called in Sulzer to help.

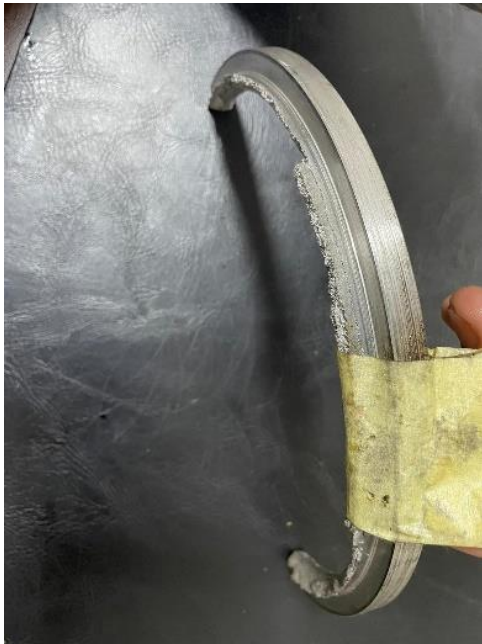
Image 4: The damage to the compressor was such that the rotor needed to be re-engineered and new components manufactured.

The damage to the compressor was such that the rotor needed to be re-engineered and new components manufactured. Sulzer has a well-practiced procedure that uses 3D laser scanning to create digital reconstructions of all the components to enable precision parts to be produced in-house. Additional support was provided by

Wijnand Hemsen, Area Sales Manager for Sulzer, concludes: "From this point, our turbomachinery experts will manufacture new parts for the rotor, repair damage to the casing, reassemble the compressor and ship it back to the customer. Local field services from Sulzer will complete the installation and commissioning.
