Full steam ahead

27 February 2024

Sulzer restores operational integrity of steam turbine on container ship

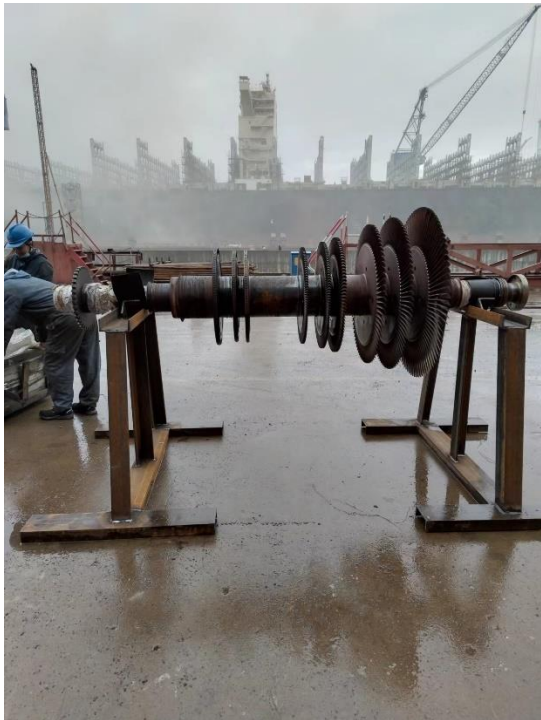
Image 1: An 18-year-old 5 MW steam turbine installed on a 98'000-ton container ship suffered damages due to operational wear and tear.

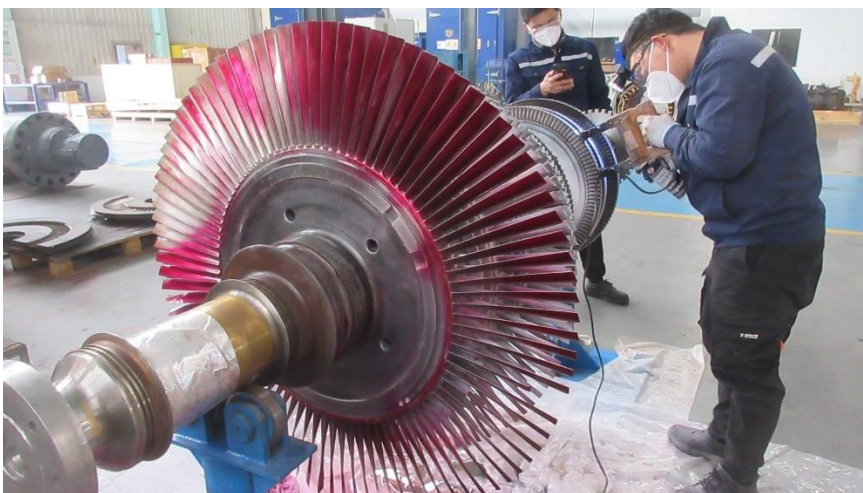
Image 2: Sulzer teams in China, Singapore and Indonesia collaborated to determine the best approach for repair.

Sulzer teams in China, Singapore and Indonesia collaborated to determine the best approach for repair. A strong network of dedicated service centers across Asia and the rest of the world ensures that every project receives the best possible level of technical expertise and engineering capabilities, as local teams can tap into Sulzer's global community of experts.

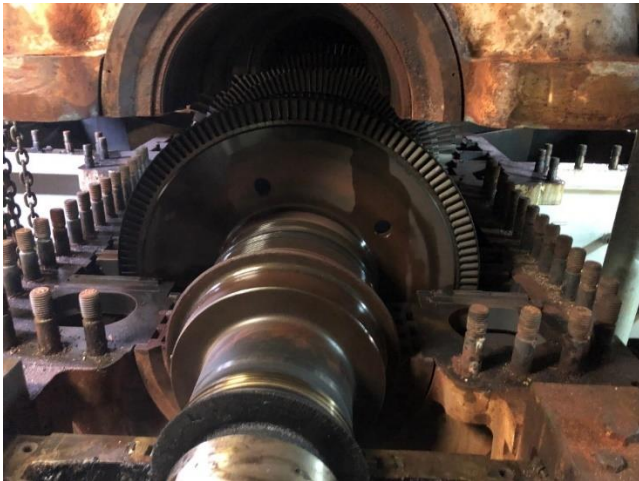
Image 3: For a working vessel, all maintenance must be completed within the timeframe that the ship is in harbor.

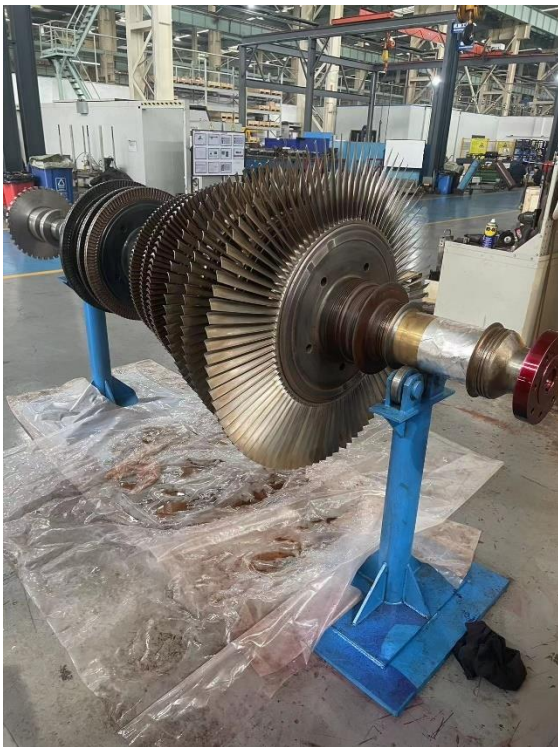
Image 4: Following reverse engineering, Sulzer manufactured new blades and re-bladed the turbine in-house, among other repairs.

The damaged stages were all re-bladed, with erosion shields added to improve service life. Sulzer's Purwakarta Service Center in Indonesia carried out the manufacture of new turbine blades in-house. To ensure the new blades were a perfect fit, the original components were reverse engineered. In total, 125 blades were produced for stage 3, 97 for stage 8 and 96 for stage 9. Preparation and logistical coordination ahead of the repair window ensured that all could be delivered to deadline.
